Manhole Inspection Summary

Manhole # S67O__014MH

Insp Date: **2/7/08 11:00 AM**

Location Address: **6500 Boston St.**

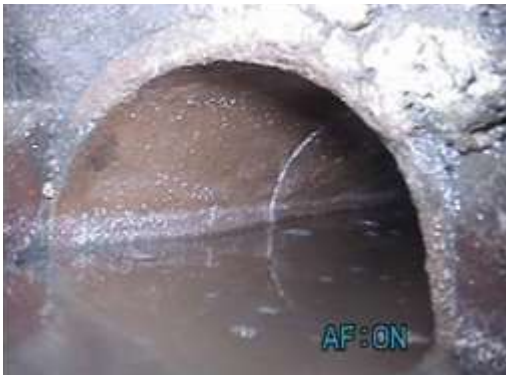
Defect 1

I-8 Circumferential fracture 9:00-3:00

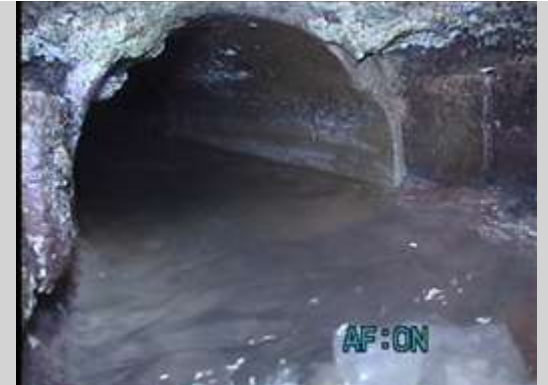
12 O'Clock Outflow

10 in. Circular Gravity Sewer
Pipe Out @ 12 O'Clock

Pipe Height: **10.8** (in.) Rod and Bar (Angled)
Pipe Material: **Clay** ☐ Pipe Lined
Invert Depth: **5.00** (ft.) Flow Characteristics: **Fast**
Deposits: ☒ None ☐ Mud ☐ Sludge ☐ Debris ☐ Grease
Silt Depth: (in.) Deposits Extent:
Infiltration: **None** Pipe Seal Cond: **Sound**

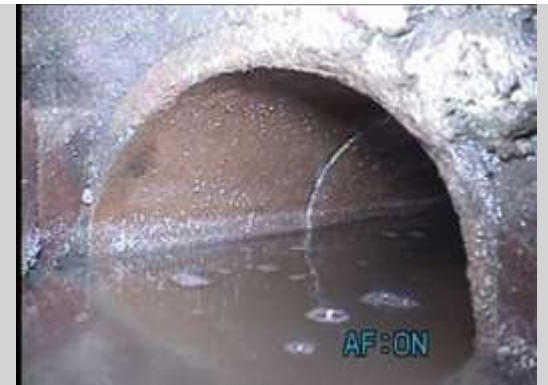
8 O'Clock Inflow

8 in. Circular Gravity Sewer
Pipe In @ 8 O'Clock

Pipe Height: **8.4** (in.) Rod and Bar (Angled)
Pipe Material: **Clay** ☐ Pipe Lined
Invert Depth: **4.92** (ft.) Flow Characteristics: **Fast**
Deposits: ☒ None ☐ Mud ☐ Sludge ☐ Debris ☐ Grease
Silt Depth: (in.) Deposits Extent:
Infiltration: **None** Pipe Seal Cond: **Sound**
